# Influence of assembly methods and thermal cycling on MLCC capacitors on crack appearance. Microsection study

C. López-López, E. Torres, S. Reina, C. Marcos, M. Dominguez, J.M. Jimenez

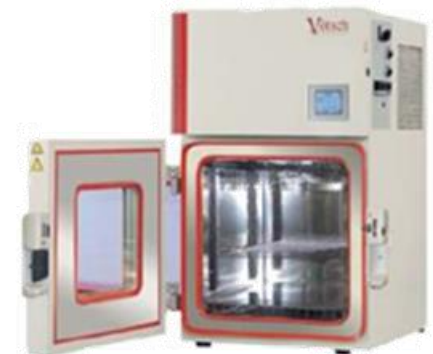
Control software

- The test specimen shall be temperature cycled in an air circulating or inert gas purged oven.
- Before the start of the temperature cycling, the test specimen shall be baked-out to remove the internal humidity.
- The bakeout temperature shall be between 60 °C and 80 °C
- The temperature cycle shall be between -55 °C and +100 °C

Ramp Temperature Condition:

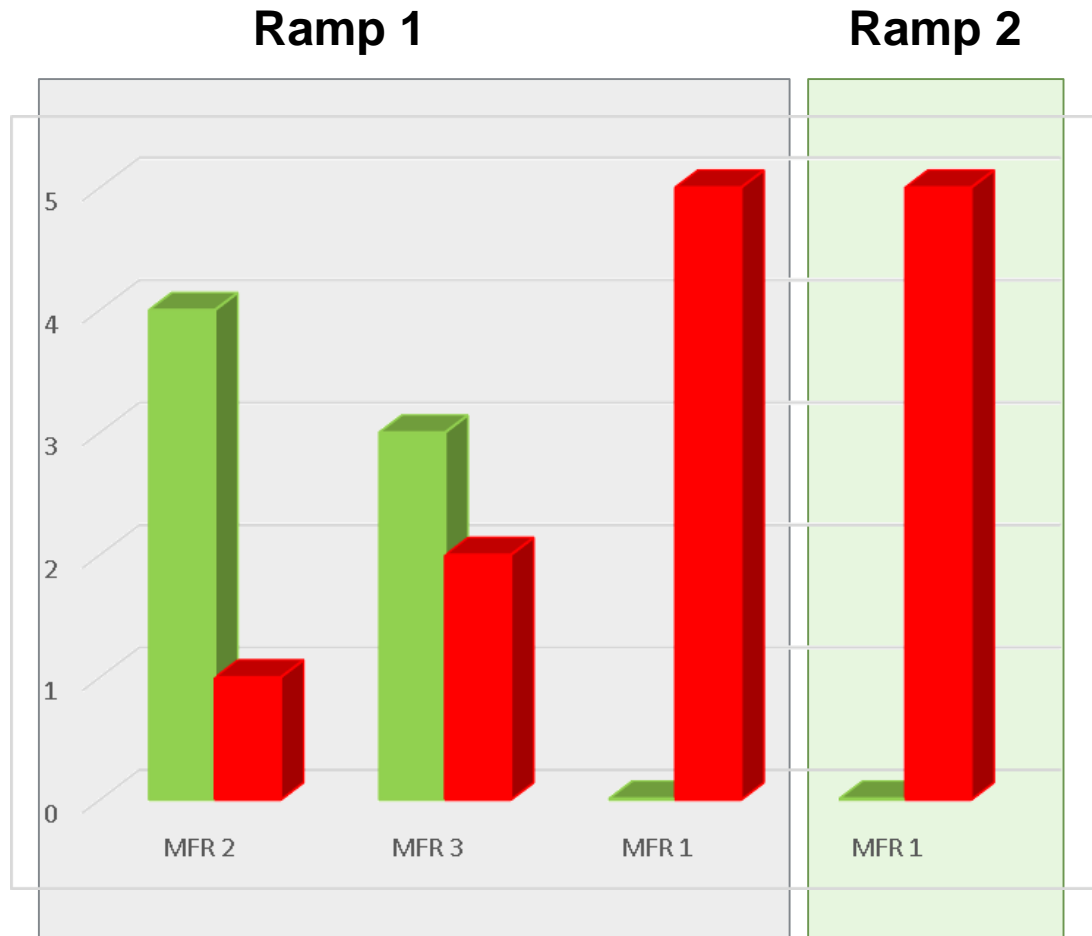
## HS Process I Type II

**Type II: results are linked to manufacturer.**

### **No satisfactory results**

- **MFR 2:** 1 out of 5 with crack in the ceramic.
- **MFR 3:** 2 out of 5 with crack in the ceramic.
- **MFR 1:** 5 out of 5 failed.
- **No differences** between ramp 1 and ramp 2.
